# SUMMARY

May 3, 2024

Tim Bronk  
Mr. Bronk's Property Inspections  
406-381-8152  
tim@mrbinspections.com

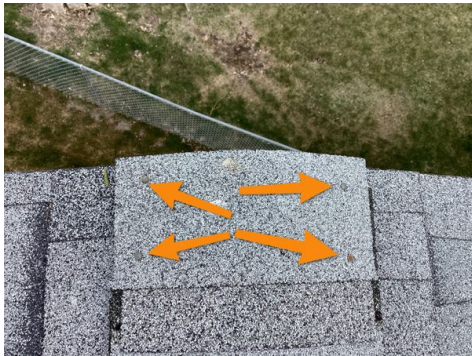
Ridge Cap

### EXPOSED FASTENERS

I observed indications of exposed fasteners at the roof-covering materials. Fasteners should not be exposed—potential water entry points. The roof could leak. Further evaluation and correction are recommended.

Contact a qualified roofing professional.

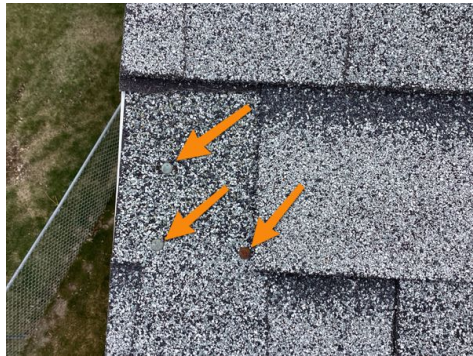
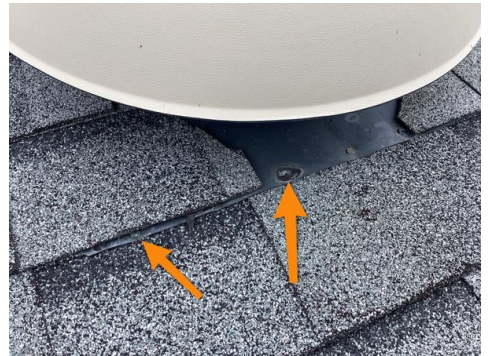
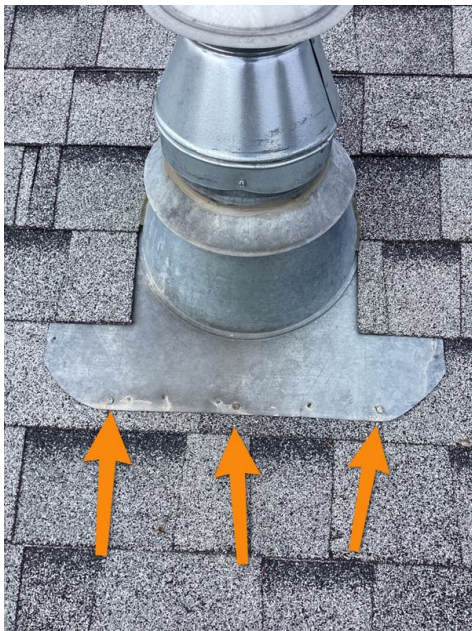
Major Defect

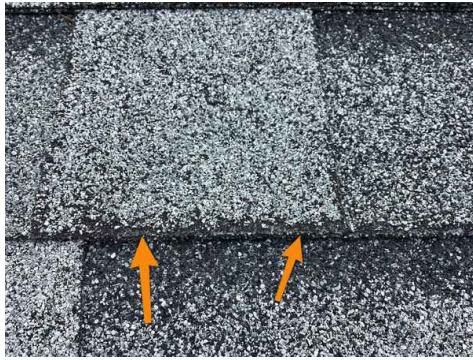
West

### DELAMINATION

The asphalt shingle roof shows signs of delamination. Delamination is the separation of the surface layer of asphalt. Recommend a qualified roofing contractor evaluate and repair to prevent further deterioration that results in leaking and moisture intrusion.

Contact a qualified roofing professional.

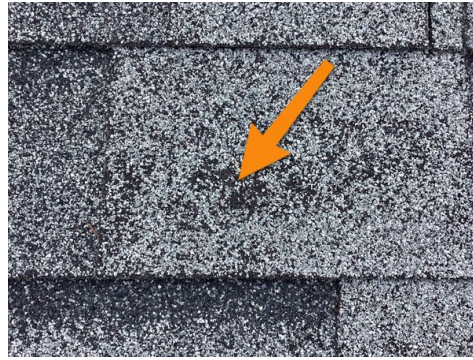
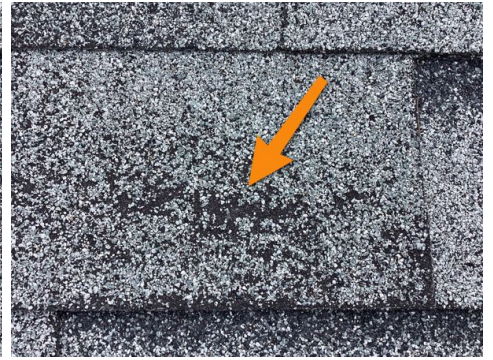
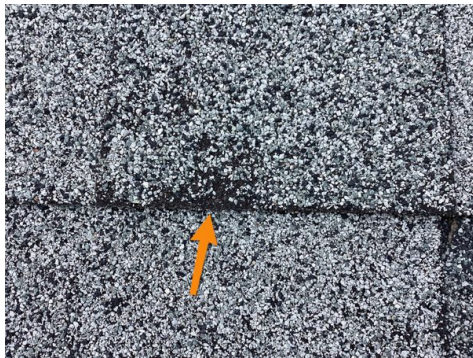
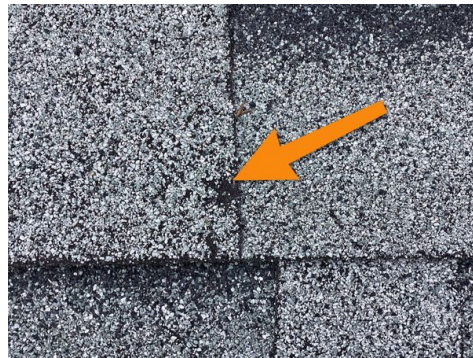
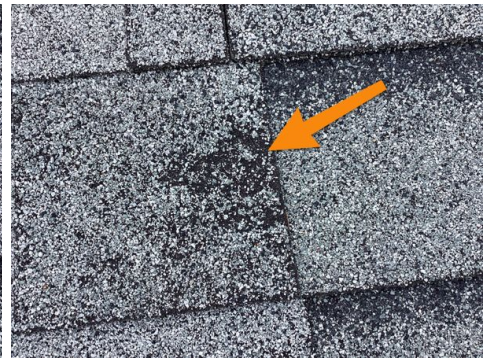
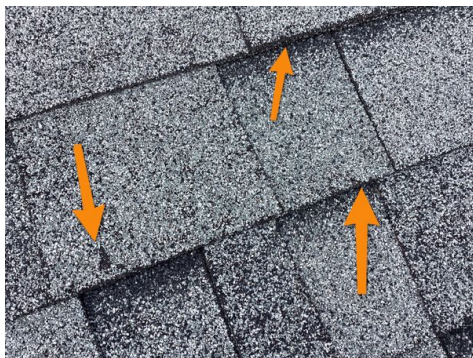
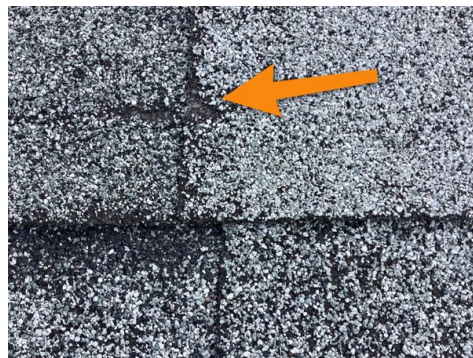
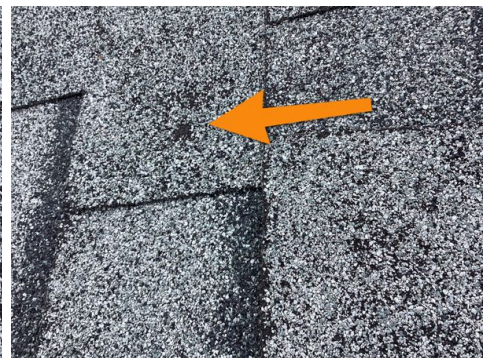
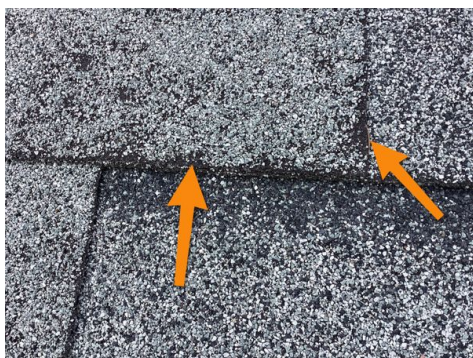
Major Defect

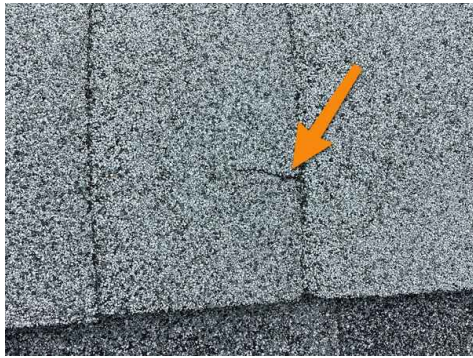
Ridge Cap

**CRACKED AND DAMAGED ROOF COVERING**

I observed areas of cracked/splitting and damaged roof-covering materials. This is a major defect. Prone to water leaking into the house. I recommend that a qualified roofing contractor evaluate further and make repairs to the roof system,

Recommendation  
Contact a qualified roofing professional.

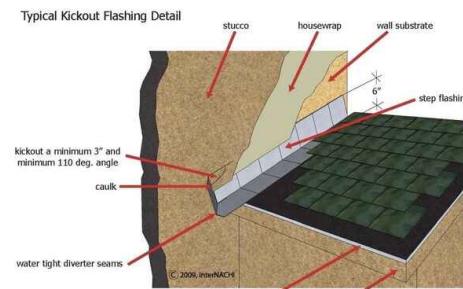
Sample Flashing Diagram

### 2.3.1 Flashings & Ridge Cap **MISSING KICKOUT FLASHING**

I observed a defect in the flashing area called a "kickout." It's missing. It is not installed. A kickout flashing "kicks" the roof water away from the house structure and diverts it into a gutter. This missing flashing could lead to hidden moisture intrusion and water damage issues that I could not observe during a visual-only home inspection. A roofing professional is needed to evaluate further and make necessary corrections.

Recommendation  
Contact a qualified roofing professional.

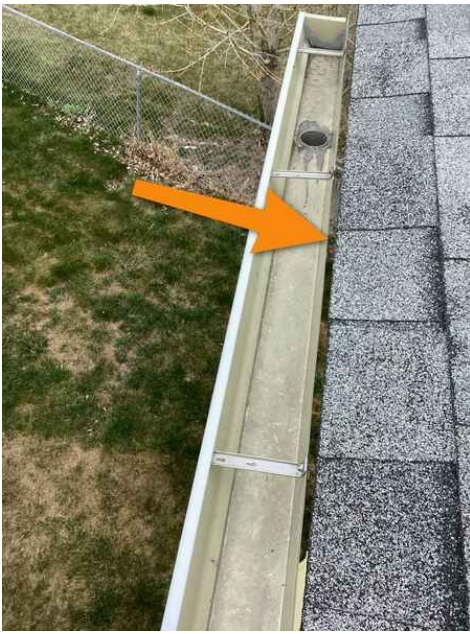
West

### 2.6.2 Gutters & Downspouts **GUTTER LOOSE**

I observed a gutter that was loosely attached to the house. This is a defect that a professional contractor should correct.

Recommendation  
Contact a qualified gutter contractor

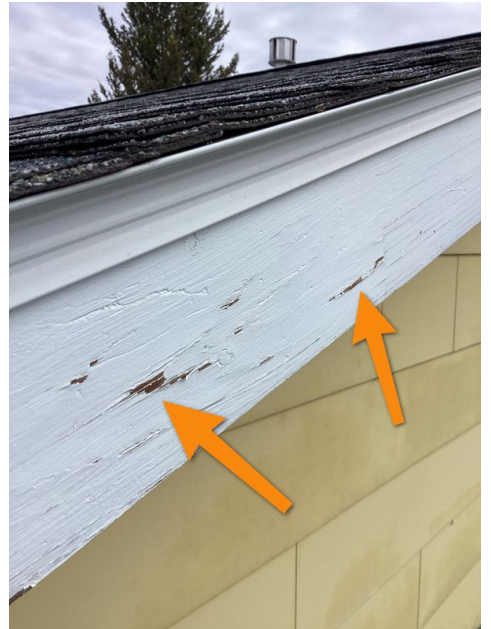
South

#### **PAINT SURFACE IN POOR CONDITION**

I observed indications of paint or staining in poor condition. Flaking, cracking, and worn areas.

Correction and further evaluation are recommended.

Contact a qualified painting contractor.

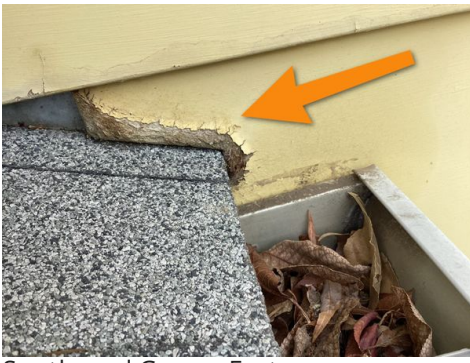
South, and Garage East

#### **DAMAGED WALL-COVERING MATERIAL**

I observed indications of a defect at the exterior wall-covering material.

Correction and further evaluation are recommended.

Contact a qualified professional.

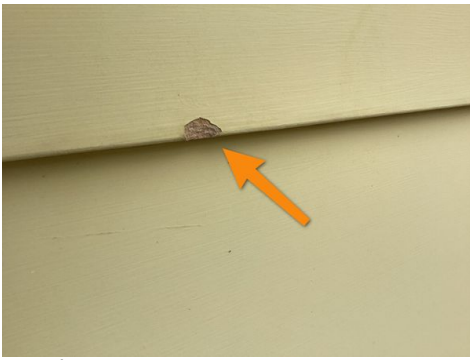
South

#### **CHIPPING, PEELING, DETERIORATING PAINT/FINISH**

I observed areas of chipping, peeling, or deterioration of the exterior wall-covering paint/finish.

Correction and further evaluation are recommended.

Contact a qualified professional.

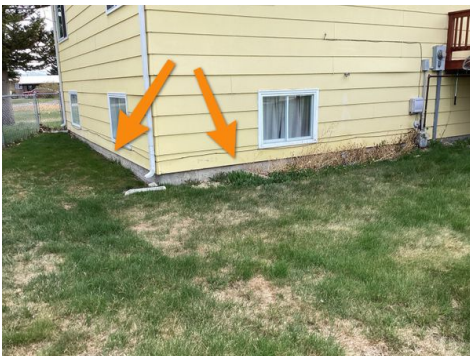
North,

#### **NEGATIVE GRADING**

Grading is sloping towards the home in some areas. This could lead to water intrusion and foundation issues.

The ground around a house should slope away from all sides, ideally 6 inches for the first 10 feet from the house foundation perimeter. Downspouts, surface gutters, and drains should direct water away from the foundation.

Contact a qualified landscaping contractor

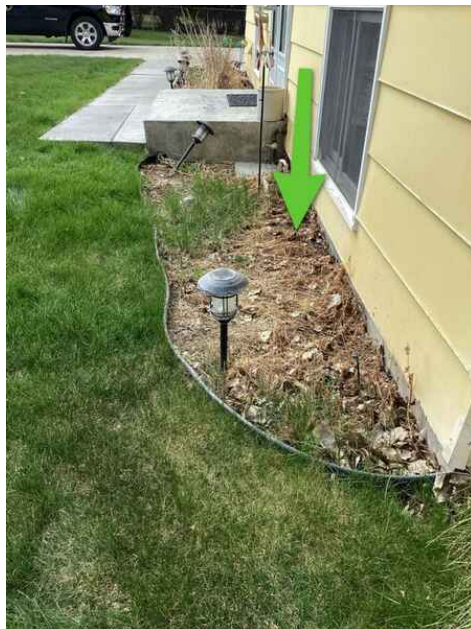
Major Defect

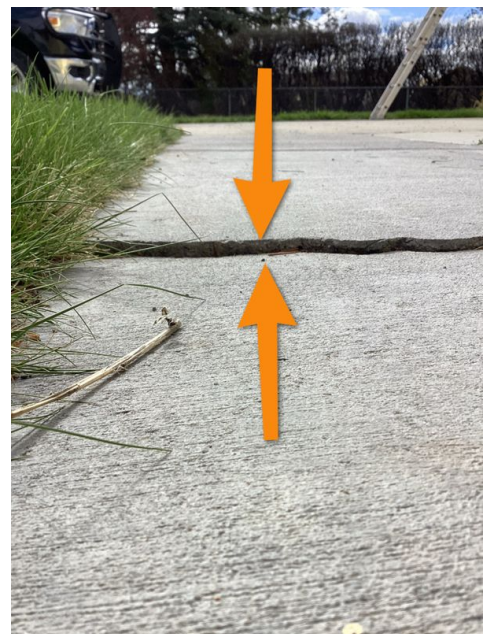
East

#### TRIP HAZARD

I observed a trip hazard. Any change in surface level that is a ¼ inch or more constitutes a tripping hazard. This condition is a safety concern.

Correction and further evaluation are recommended.

Contact a handyman or DIY project

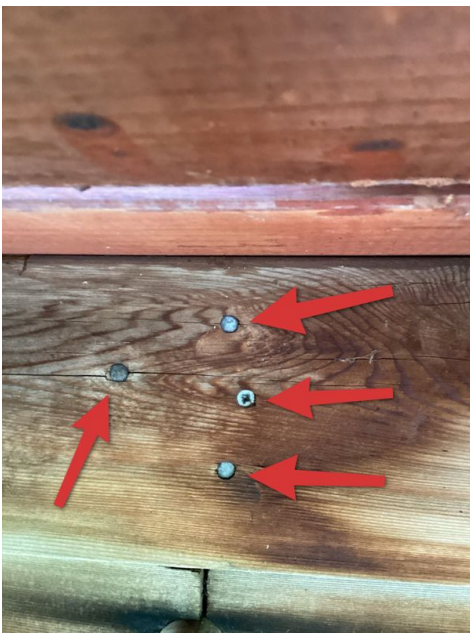
West

#### LEDGER BOARD DEFECT

I observed indications of a defect on the ledger board of the deck.

The ledger board is not correctly attached to the building. This can cause the deck to pull away from the building and possibly collapse. It is a material defect.

Further evaluation and correction by a qualified contractor are recommended.

Contact a qualified deck contractor.

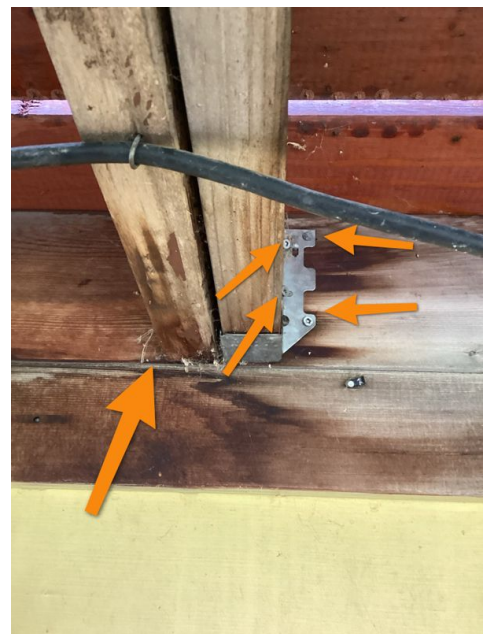
West

**JOIST HANGER DEFECT**

I observed a defect at the joist hangers of the deck. This condition is a major structural defect.

Correction and further evaluation are recommended.

Contact a qualified deck contractor.

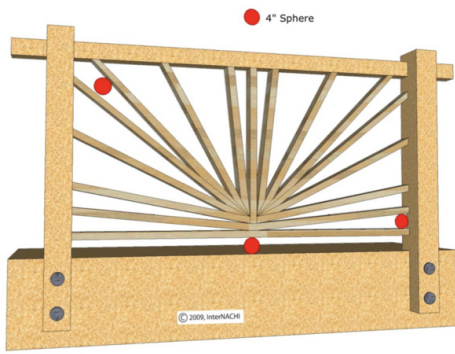
4-inch sphere opening at a guard

**GUARD OPENING WAS TOO LARGE (4")**

I observed improper spacing between intermediate balusters, spindles, and rails at a required guard. This is a safety hazard, especially for small children.

Guards may not allow the passage of a sphere 4 inches in diameter.

Correction and further evaluation are recommended.

Contact a qualified general contractor.

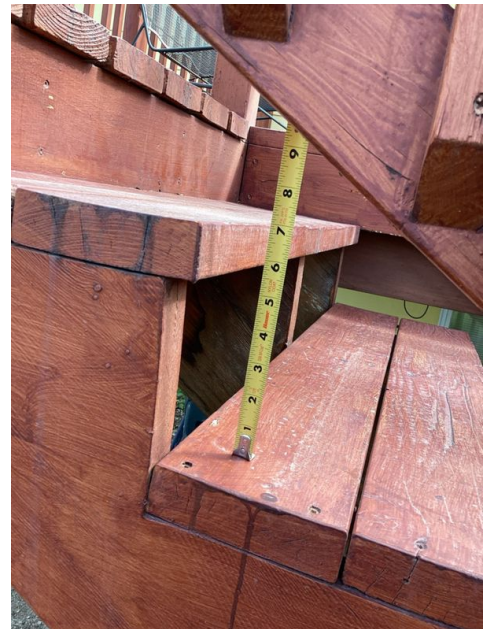
West

## STAIR GUARD OPENING WAS TOO LARGE (6")

I observed improper spacing between intermediate balusters, spindles, and rails. This is a safety hazard, especially for small children.

And opening at the guard on the open side of a stair formed by the riser, the tread and bottom rail of the guard should not allow the passage of a sphere 6 inches in diameter.

Correction and further evaluation are recommended.

Contact a qualified general contractor.

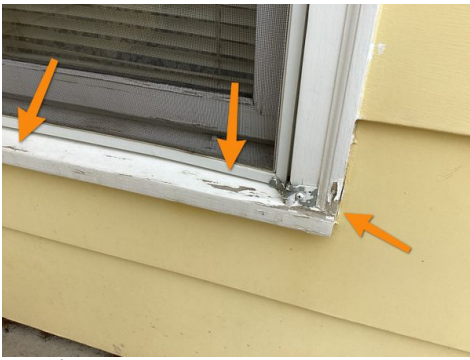
South

## PEELING PAINT

I observed chipping, peeling, or deterioration of the paint/finish in one or more of the window systems' exteriors.

Correction and further evaluation are recommended.

Contact a qualified professional.

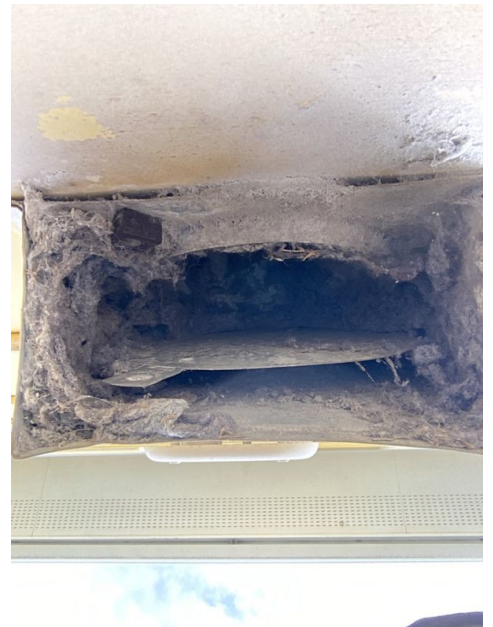
Dryer, East

#### **DAMAGED, MISSING, OR INOPERABLE EXHAUST HOOD LOUVERS**

I observed the dryer vent hood louver to be inoperable. Damaged and dirty vent hoods prevent them from operating as intended, which can reduce airflow or correct louver operability. Inoperable vent louvers can allow pests and rodents to enter the home. A qualified contractor should evaluate and repair as necessary.

Contact a qualified professional.

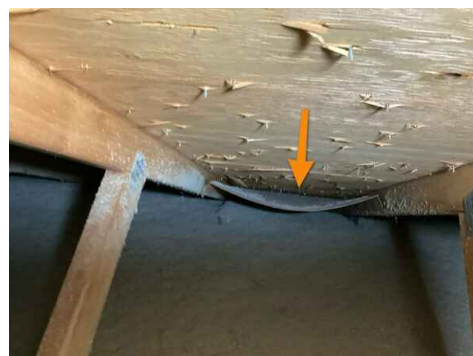
East

### SOFFIT VENTING RESTRICTED

I observed restrictions in the insulation baffle's soffit venting air flow space. A qualified contractor should evaluate and correct as necessary.

Recommendation  
Contact a qualified professional.

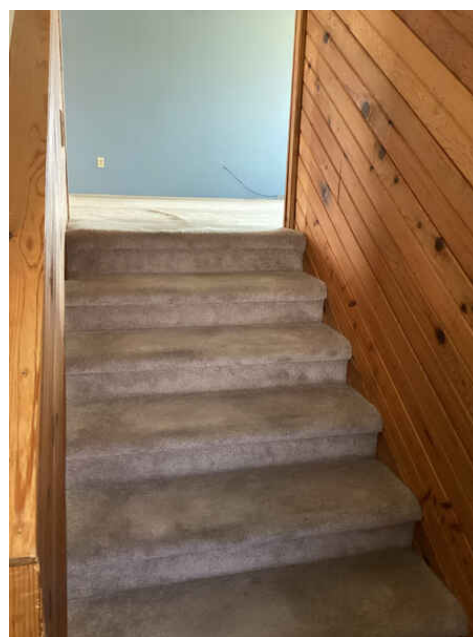
Upper Level Stairs

### MISSING HANDRAIL

I observed a missing graspable handrail. This condition is a safety hazard.

There is more than one step here, and I recommend installing a handrail for safety.

Recommendation  
Contact a qualified professional.

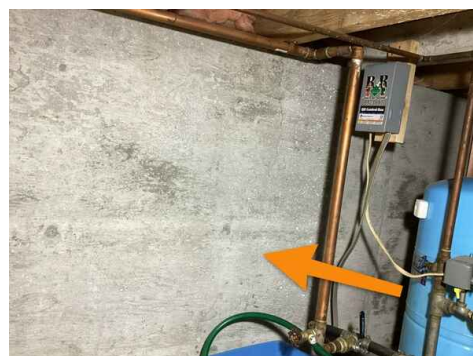
East - Under Stairs Foundation Wall

### GENERAL ABSENCE OF INSULATION

I observed indications of the general absence of insulation in the foundation area.

Recommendation  
Contact a qualified insulation contractor.

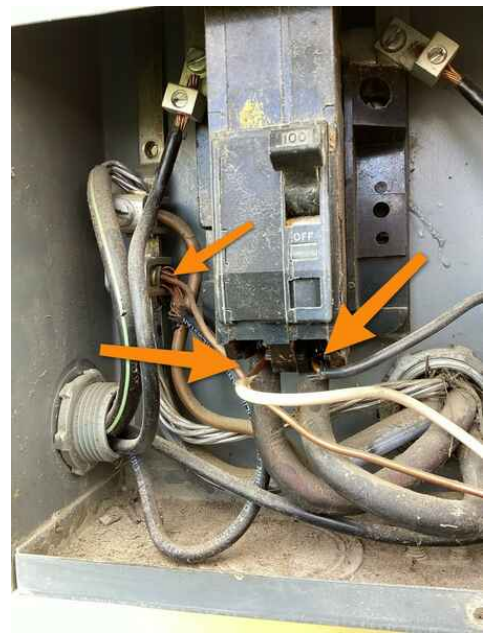
West, House - 100 AMP

### DOUBLE TAPED WIRES

I observed double conductor wires connected to the same single breaker disconnect.

Each breaker should have just one conductor wire connected to it. A qualified electrical contractor should evaluate and correct this as necessary.

Contact a qualified professional.

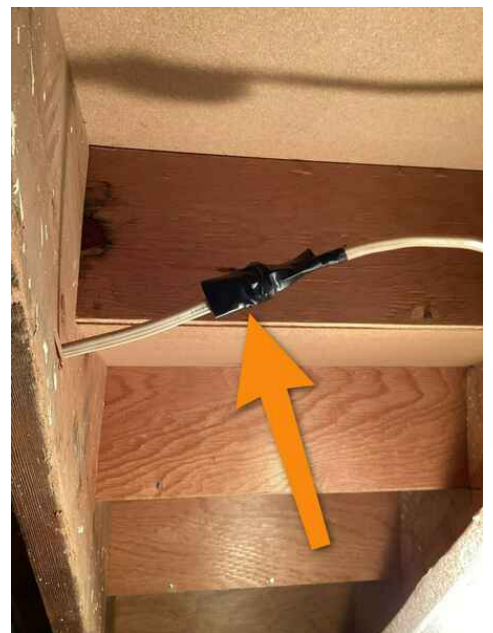
Under Stairs

### EXPOSED LIVE ELECTRICAL WIRES

I observed exposed live electrical wires. Hazardous condition.

Contact a qualified electrical contractor.

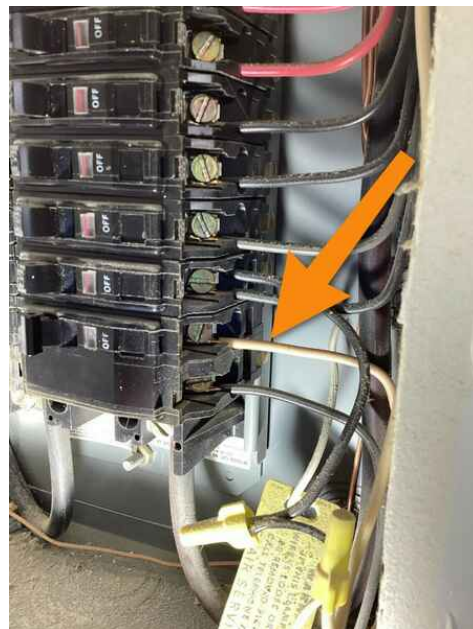
Laundry Room

### BREAKER INCORRECTLY WIRED

Circuit breaker was incorrectly wired / installed. This indicates that work was probably not performed by a licensed electrician and poses a safety hazard. Recommend that a licensed electrician check the entire panel and repair and replace as need.

Recommendation  
Contact a qualified electrical contractor.

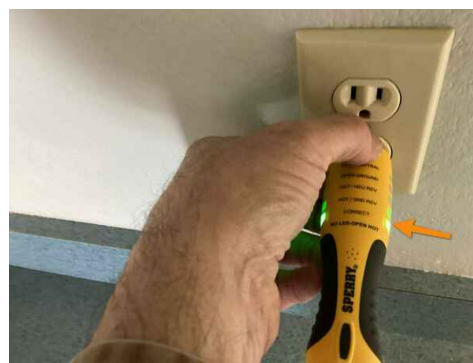
Kitchen

### 6.8.1 GFCIs **MISSING GFCI**

I observed that a GFCI is missing in an area required to keep people safe. Specifically, kitchen outlets were not protected by GFCI. A qualified electrician should evaluate and correct as necessary.

Recommendation  
Contact a qualified electrical contractor.

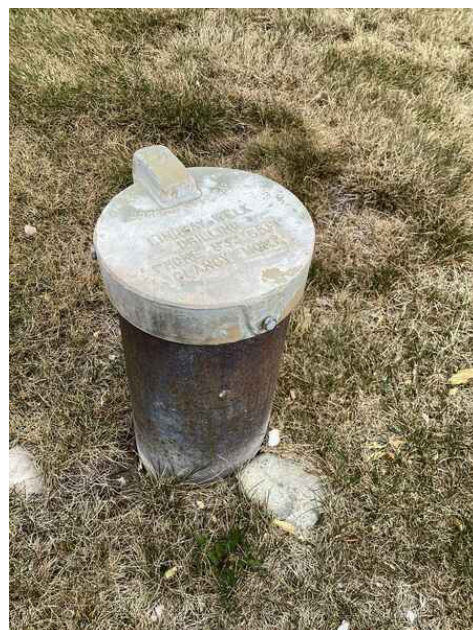
East

### 7.1.1 Water Supply **NEGATIVE GRADING**

Grading is sloping towards the wellhead. This could lead to water intrusion and well contamination.

The ground around a wellhead should slope away, ideally 6 inches from the wellhead perimeter for the first 10 feet. Surface drainage should direct water away from the wellhead area.

Recommendation  
Contact a qualified landscaping contractor

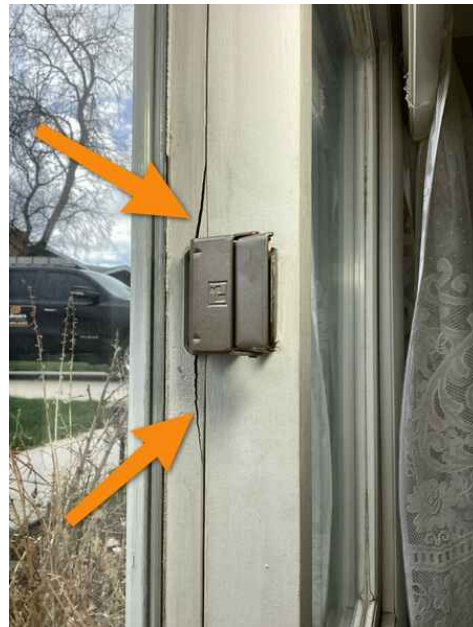
Laundry Room

**WINDOW DAMAGE**

I observed damage to the window stile at the locking mechanism. I recommend having the stile repaired.

Recommendation  
Contact a qualified professional.

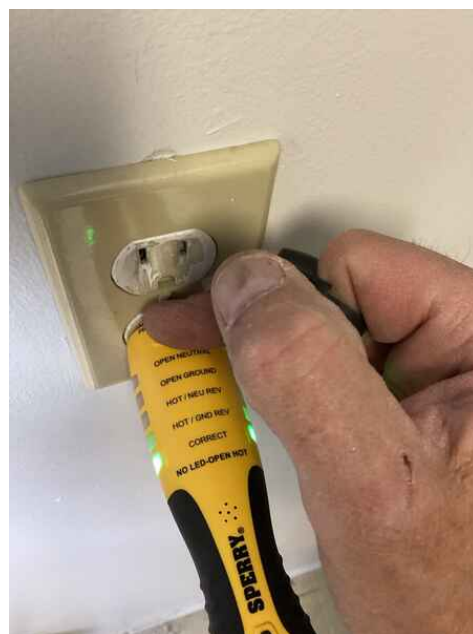
Laundry Room

**RECEPTACLE IS NOT GFCI PROTECTED**

I observed that the receptacle in the laundry room is not testing as being GFCI-protected. This is a hazardous condition.

Recommendation  
Contact a qualified electrical contractor.

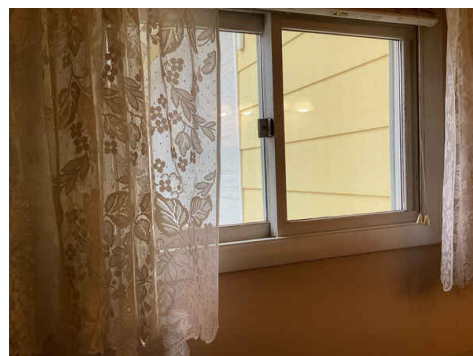
Bathroom - Lower Level

**INOPERABLE - STUCK SHUT**

I could not open the window in this room because it was stuck shut. This is an inspection restriction and a safety hazard. A qualified contractor should further evaluate and repair as necessary.

Recommendation  
Contact a qualified professional.

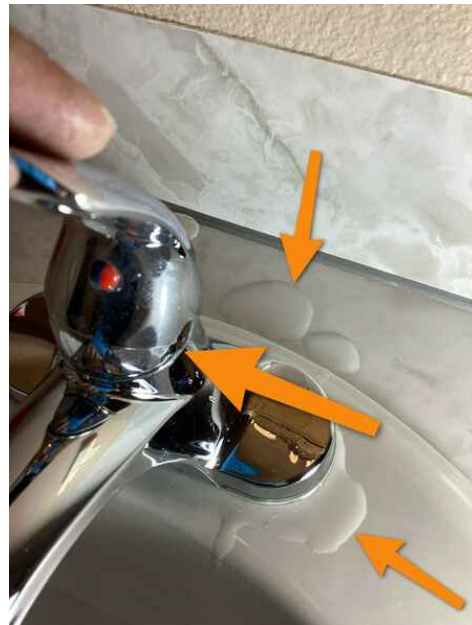
Bathroom - Lower Level

### ACTIVE WATER LEAK

I observed indications of an active water leak at the faucet fixture. I recommend having a qualified plumber evaluate and repair as necessary.

Contact a qualified plumbing contractor.

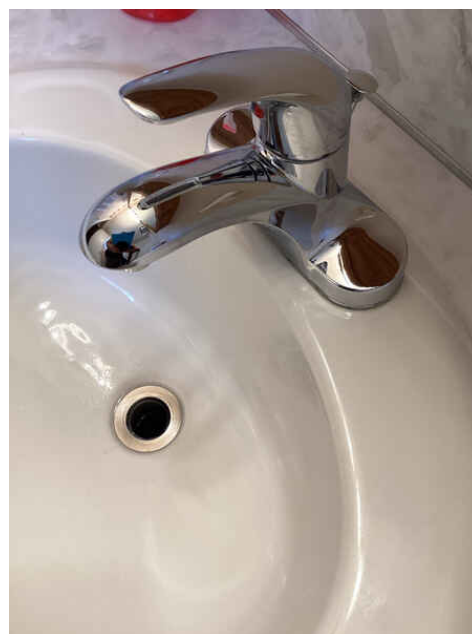
Bathroom - Lower Level

### SINK STOPPER MISSING/DEFECT

I observed indications of a missing drain stopper at the faucet fixture. I recommend having a qualified plumber evaluate and repair as necessary.

Contact a qualified professional.

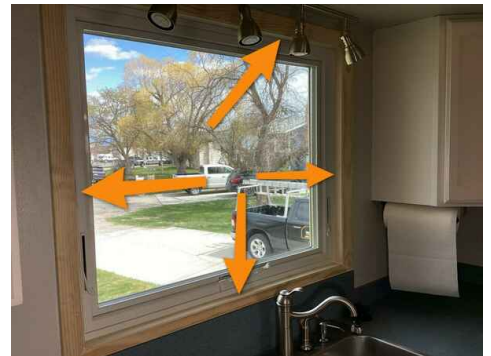
Kitchen

#### UNFINISHED TRIM

I observed that the trim around the windows was unfinished. Unfinished wood will more easily stain, discolor, rot, and decay over time. This is because it is exposed to moisture and humidity, which encourages the growth of mold and mildew. Insects, such as termites, can also damage wood. These pests can tunnel into the wood and cause extensive damage.

Contact a qualified professional.

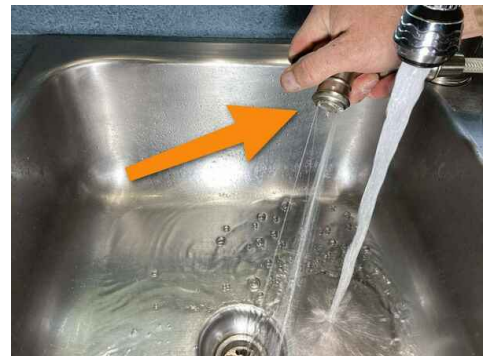
Kitchen

#### HAND SPRAYER IS PLUGGED

I observed the hand-sprayer was plugged and needs cleaning or replacement.

Contact a handyman or DIY project

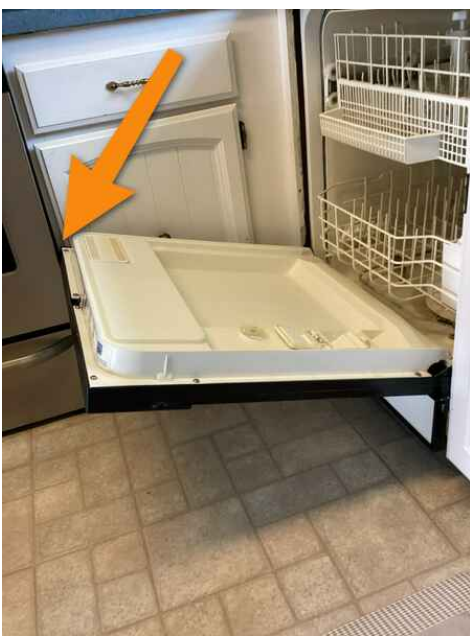
Kitchen

#### DOOR INTERFERENCE

I observed clearance interference between the dishwasher door and the range/oven. This interference prevents the dishwasher door from opening properly.

Contact a qualified professional.

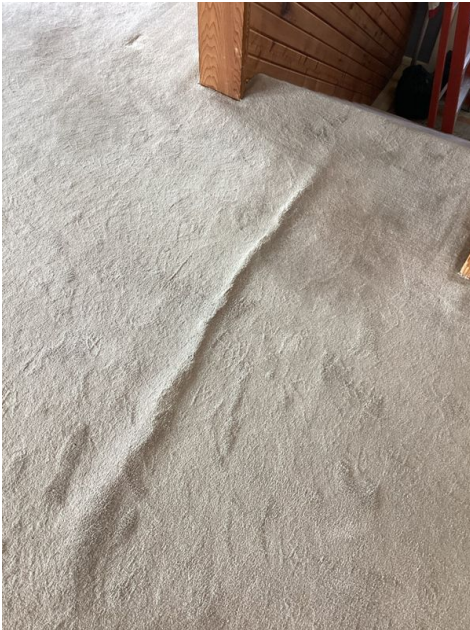
Living Room

#### **CARPER LOOSE**

Loose carpet at time of inspection. Recommend a qualified contractor re-stretch.

Contact a qualified handyman.

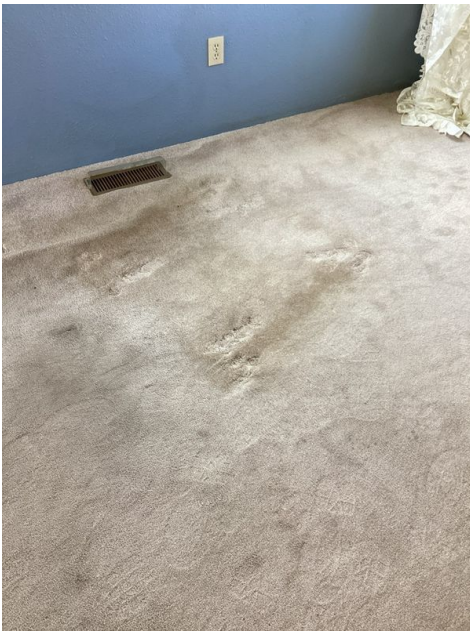
Living Room

#### **CARPET STAINS**

Carpet had areas of staining or discoloration. Recommend a thorough steam clean by a qualified carpet cleaning company

Contact a qualified cleaning service.

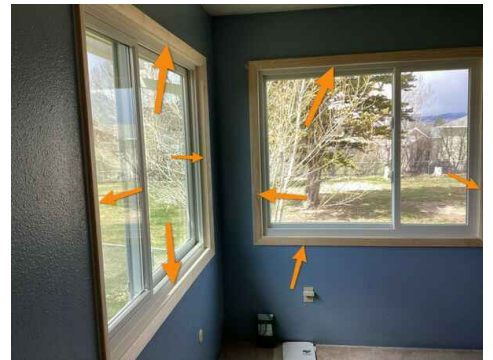
Living Room

#### UNFINISHED TRIM

I observed that the trim around the windows was unfinished. Unfinished wood will more easily stain, discolor, rot, and decay over time. This is because it is exposed to moisture and humidity, which encourages the growth of mold and mildew. Insects, such as termites, can also damage wood. These pests can tunnel into the wood and cause extensive damage.

Recommendation  
Contact a qualified professional.

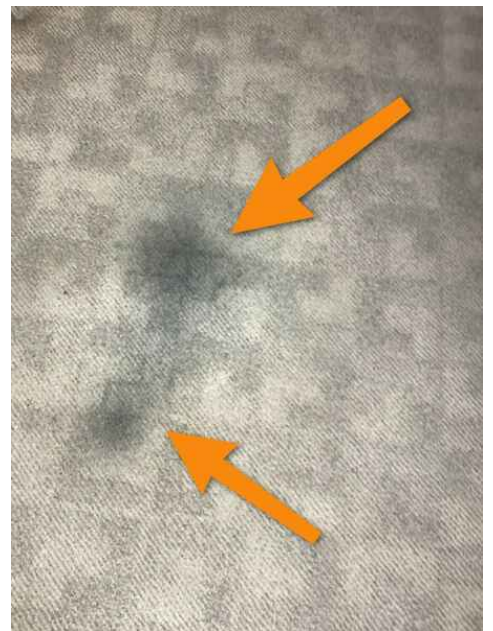
Bedroom, Northeast

#### CARPET STAINS

Carpet had areas of staining or discoloration. Recommend a thorough steam clean by a qualified carpet cleaning company

Recommendation  
Contact a qualified cleaning service.

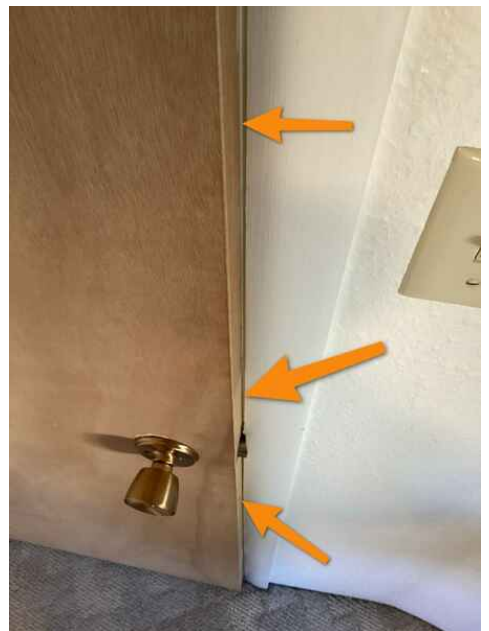
Bedroom, Northeast

### DOOR - BINDING OR STICKING

I observed the room door binding or sticking, hindering its ability to open or close correctly. This significantly affects the operation of the door. This could be caused by improper installation, shifting of the house, loose or worn hinges, or humidity. It is recommended to have a qualified contractor investigate and correct the cause to prevent potential safety hazards.

Contact a qualified handyman.

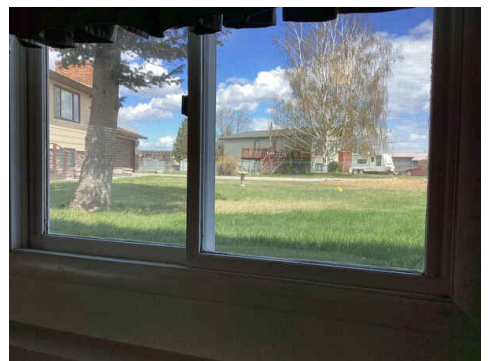
Bedroom, Northeast

### WINDOW - PAINTED OR STUCK SHUT

One or more windows are painted or stuck shut. Recommend windows be restored to functional use.

Contact a qualified window repair/installation contractor.

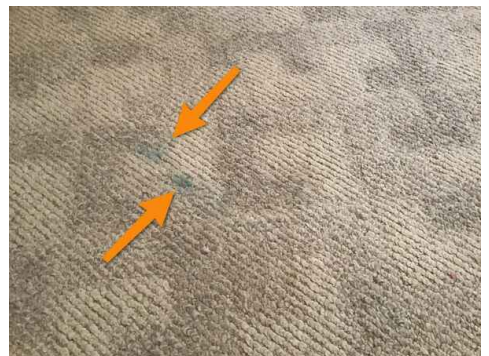
Bedroom, Northwest

### CARPET STAINS

Carpet had areas of staining or discoloration. Recommend a thorough steam clean by a qualified carpet cleaning company

Contact a qualified cleaning service.

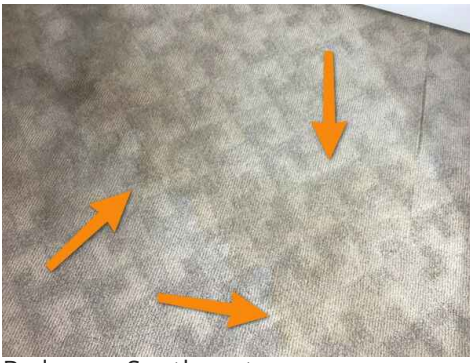
Bedroom, Southwest

### CARPET STAINS

Carpet had areas of staining or discoloration. Recommend a thorough steam clean by a qualified carpet cleaning company

Contact a qualified cleaning service.

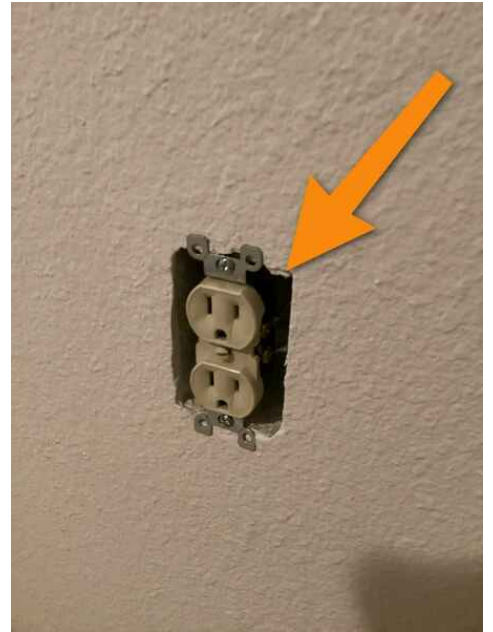
Bedroom, Southwest

**COVER PLATES MISSING**

One or more receptacles are missing a cover plate. This causes short and shock risk. Recommend installation of plates.

Contact a qualified electrical contractor.

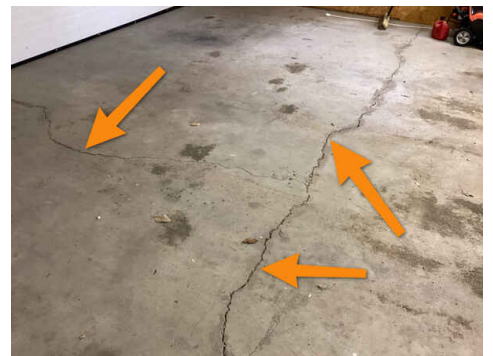
Garage

**MAJOR CRACKED CONCRETE AT GARAGE FLOOR**

I observed indications of major cracks in the garage concrete floor indicating settlement, heaving or structural problems. Further evaluation is recommended.

Contact a qualified concrete contractor.

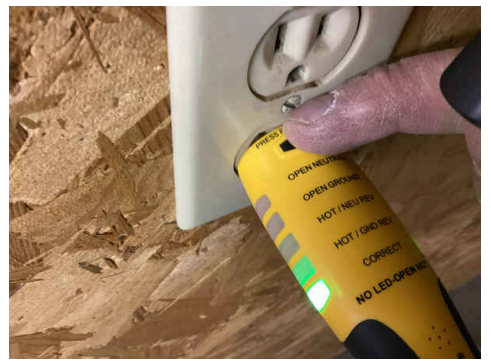
Garage

**MISSING GFCI-PROTECTION IN GARAGE**

I observed a receptacle in the attached garage without GFCI (or ground fault circuit interrupter) protection.

GFCI protection is required for all 15- and 20-amp receptacles, including outlets for refrigerators, garage door openers, and washing machines.

Recommendation  
Contact a qualified electrical contractor.

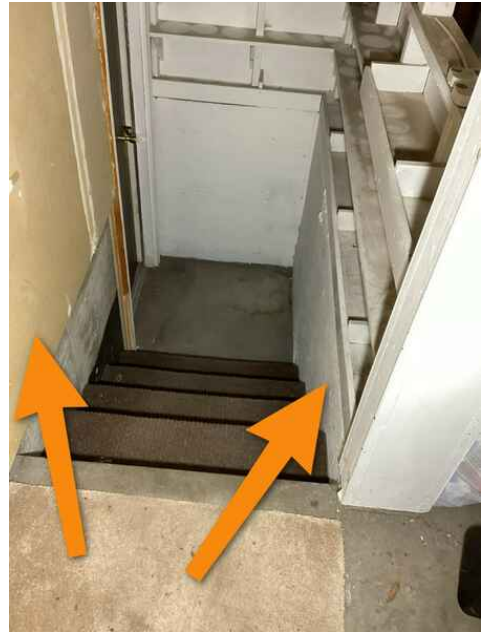
Garage

17.7.1 Stairs  
**MISSING HAND RAIL**

Recommendation  
Contact a qualified professional.

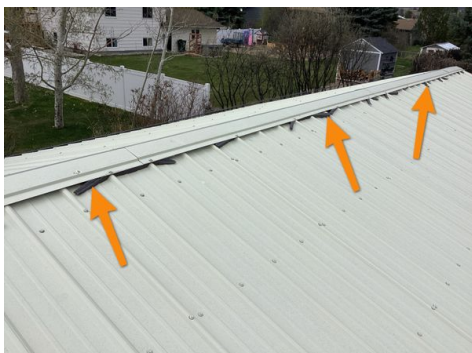
North

18.2.1 Roof Covering  
**FAILING RIDGE CAP SEAL**

Recommendation  
Contact a qualified professional.

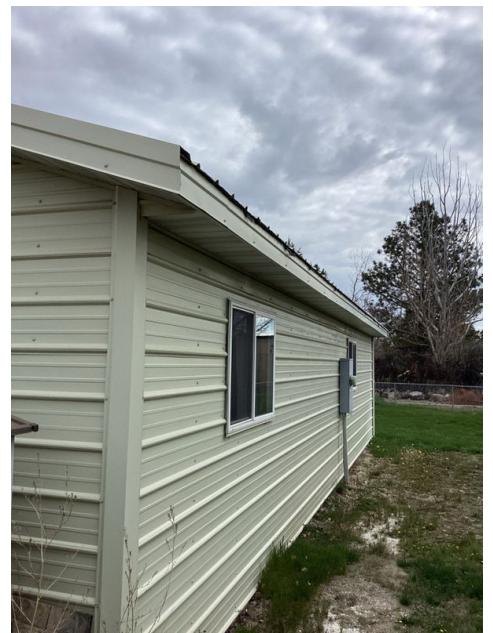
South

18.3.1 Gutters & Downspouts  
**GUTTERS MISSING**

Gutters are necessary to properly collect rain water from the roof, control it, divert it, and discharge that water away from the house and its foundation. A missing gutter is a defect. This is a defect that should be corrected by a professional contractor.

Recommendation  
Contact a qualified gutter contractor

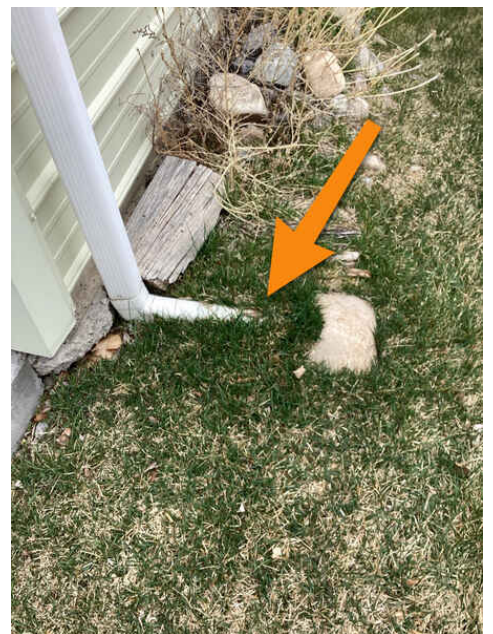
Detached Garage - West Southwest

#### **DOWN SPOUT BURIED**

I observed a downspout that was buried in the ground. I was unable to determine where it goes or how it is working. This is an inspection restriction. This should be further evaluated and verified it is working correctly.

Recommendation  
Contact a qualified professional.

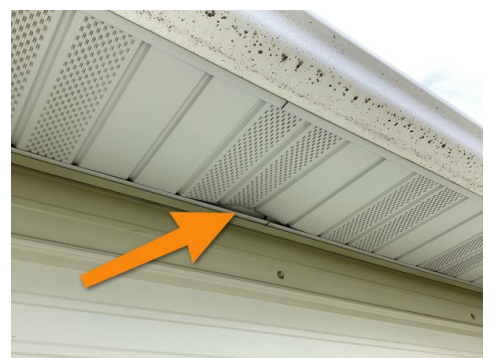
North

#### **DAMAGE OBSERVED AT SOFFIT**

I observed indications that one or more areas of the soffit were damaged.

Correction and further evaluation is recommended.

Recommendation  
Contact a qualified roofing professional.

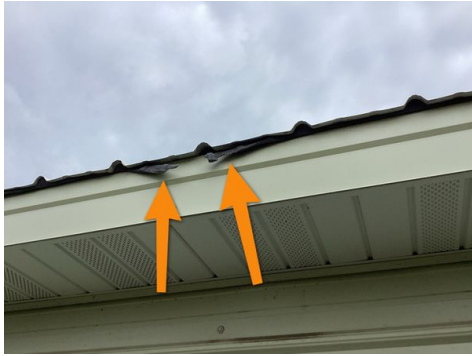
South

18.4.2 Eaves, Soffits & Fascia  
**FAILING ROOF COVERING RIB SEAL**

Recommendation  
Contact a qualified professional.

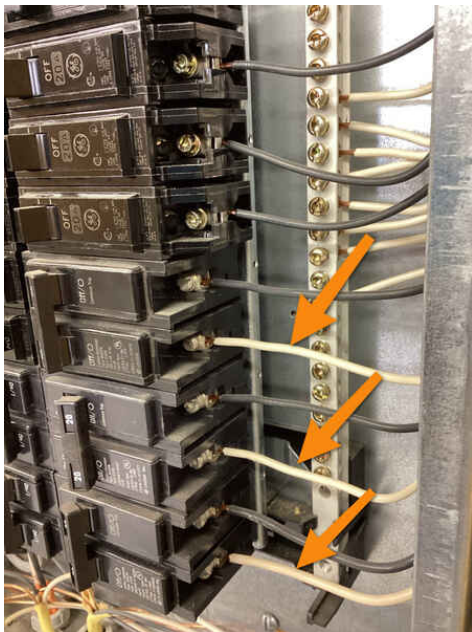
Circuit Breaker Panel

18.12.1 Electric in the Garage  
**ELECTRICAL DEFECT IN GARAGE**

I observed an electrical defect in the attached garage.

Recommendation  
Contact a qualified electrical contractor.

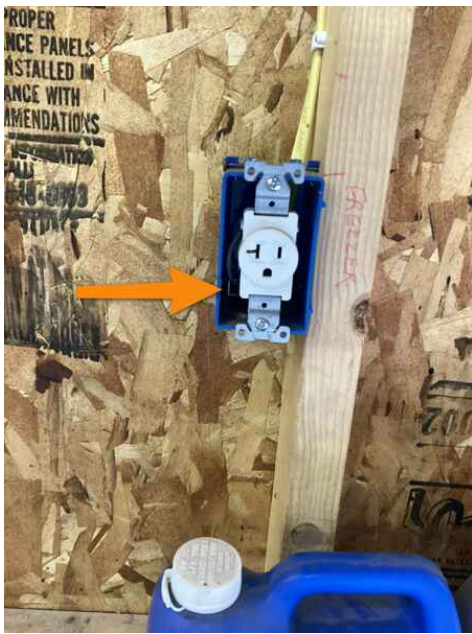
North

18.12.2 Electric in the Garage  
**MISSING RECEPTACLE COVER PLATES**

I observed missing receptacle cover plates. A qualified electrician should further evaluate and correct.

Recommendation  
Contact a qualified professional.

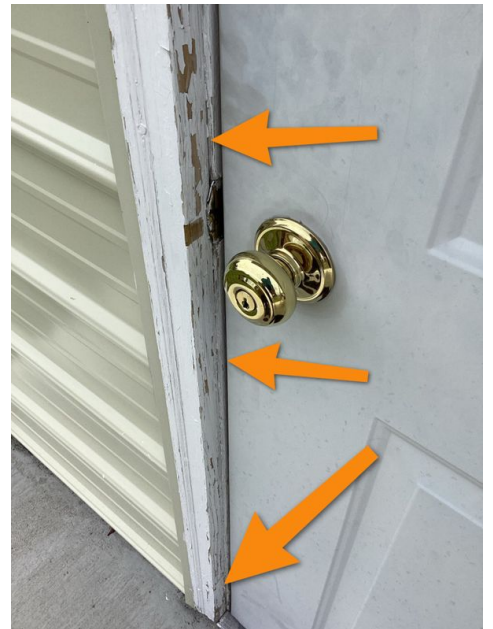
West

**DETERIORATING PAINT**

Contact a qualified professional.

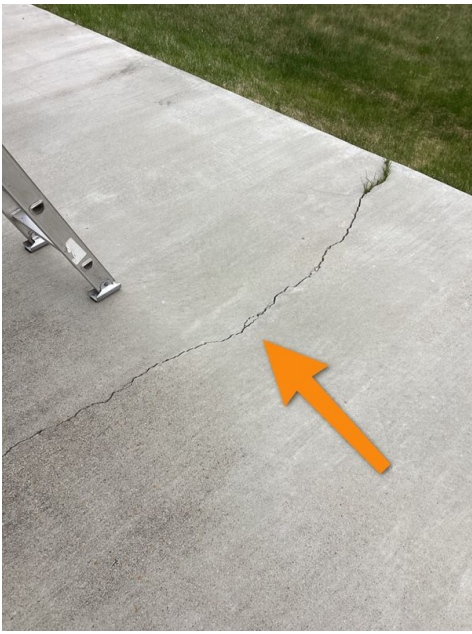
East

**CRACKED**

I observed cracks in the concrete patio of the garage.

Contact a qualified professional.
